**FINDING OF SUITABILITY TO TRANSFER**

**SALE PARCEL II - CAPEHART**

**NAVAL ACTIVITY PUERTO RICO  
CEIBA, PUERTO RICO**

**December 2007**

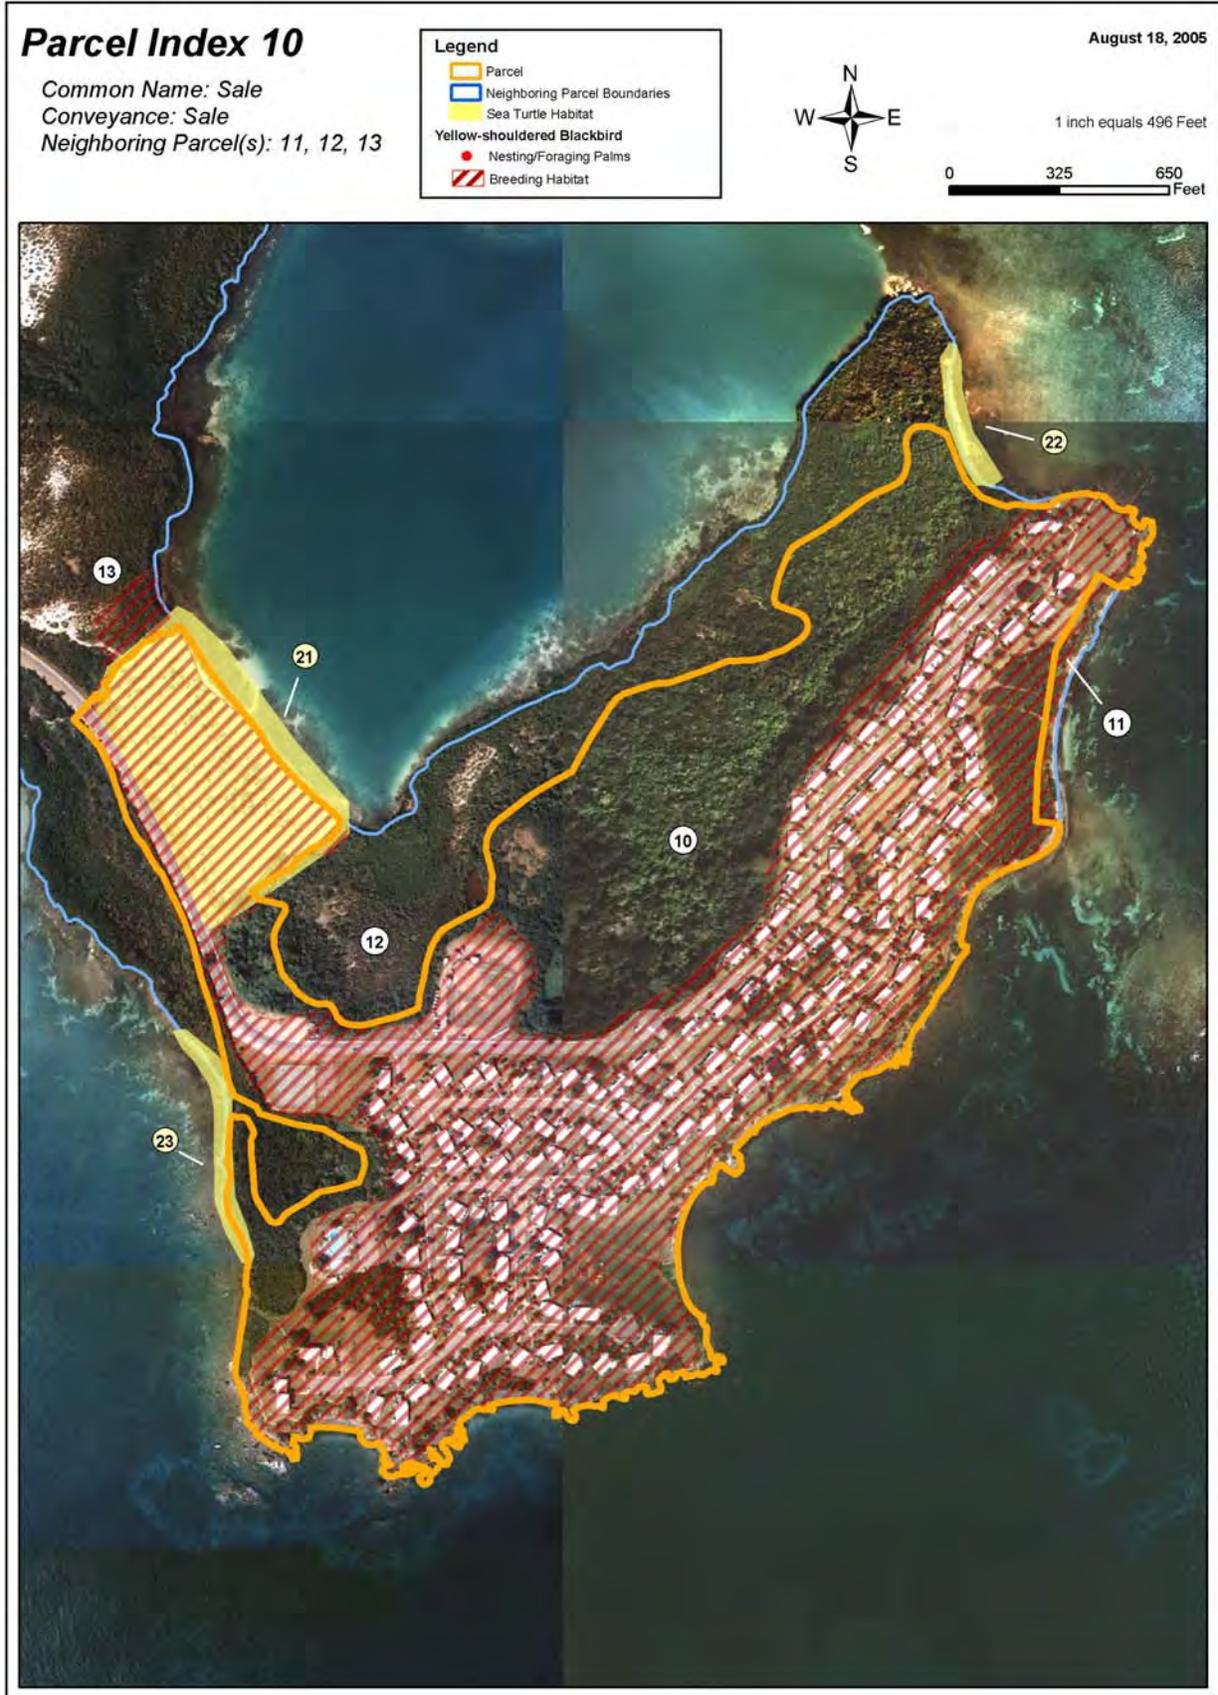
### **Parcel Index 10**

Common Name: Sale  
Conveyance: Sale  
Neighboring Parcel(s): 11, 12, 13

1 inch equals 496 Feet

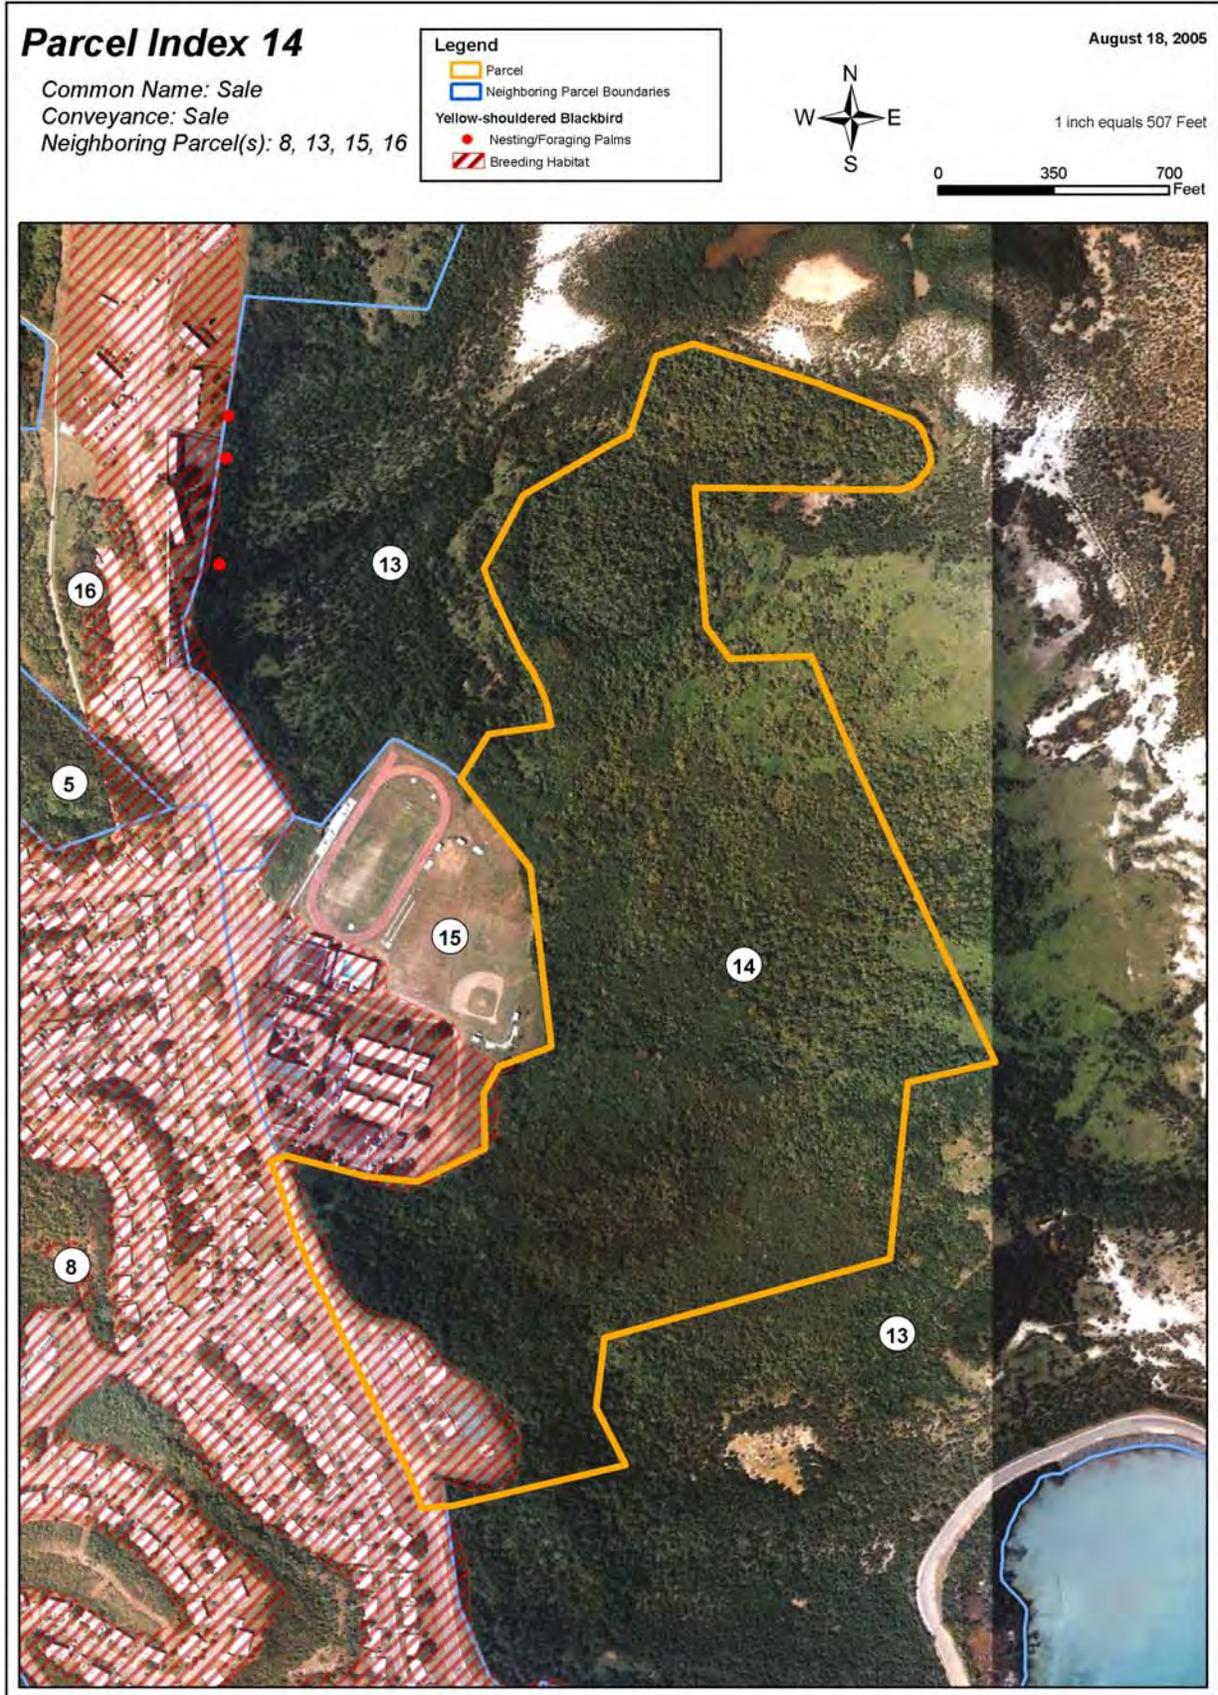
### Parcel Index 14

Common Name: Sale  
Conveyance: Sale  
Neighboring Parcel(s): 8, 13, 15, 16

1 inch equals 507 Feet

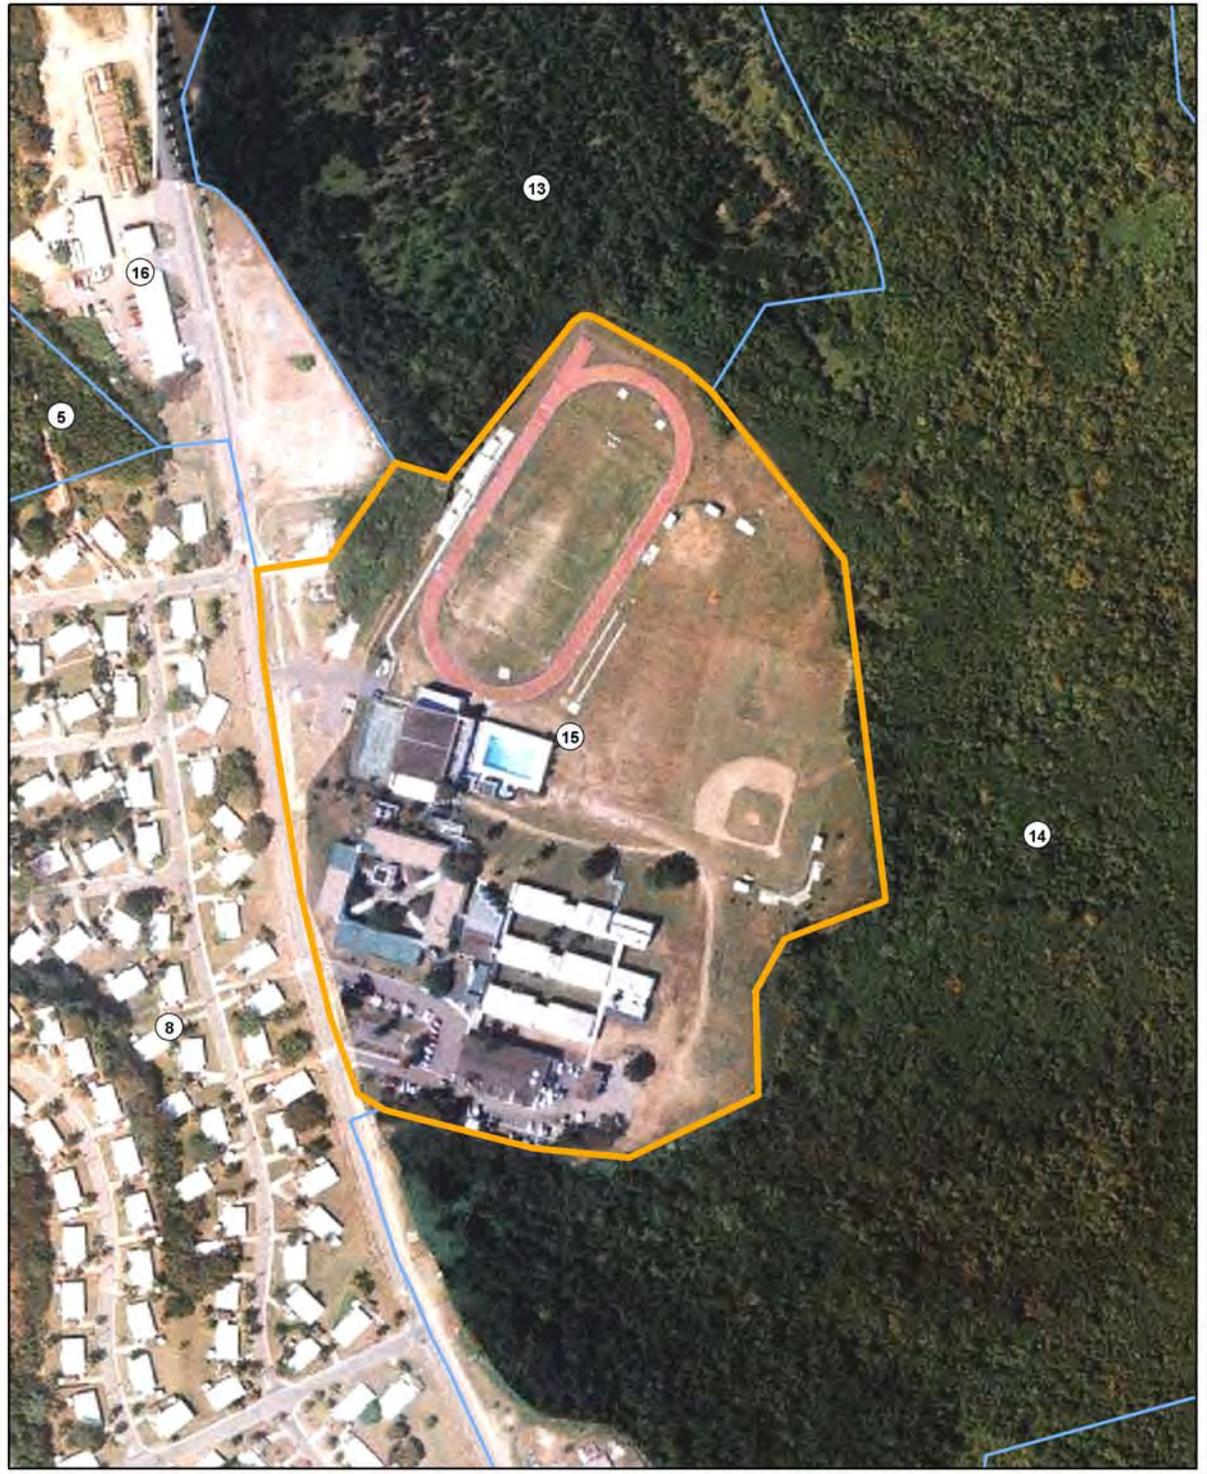
### Parcel Index 15

Common Name: Sale  
Conveyance: Sale  
Neighboring Parcel(s): 5, 8, 13,  
14, 16

1 inch equals 266 Feet

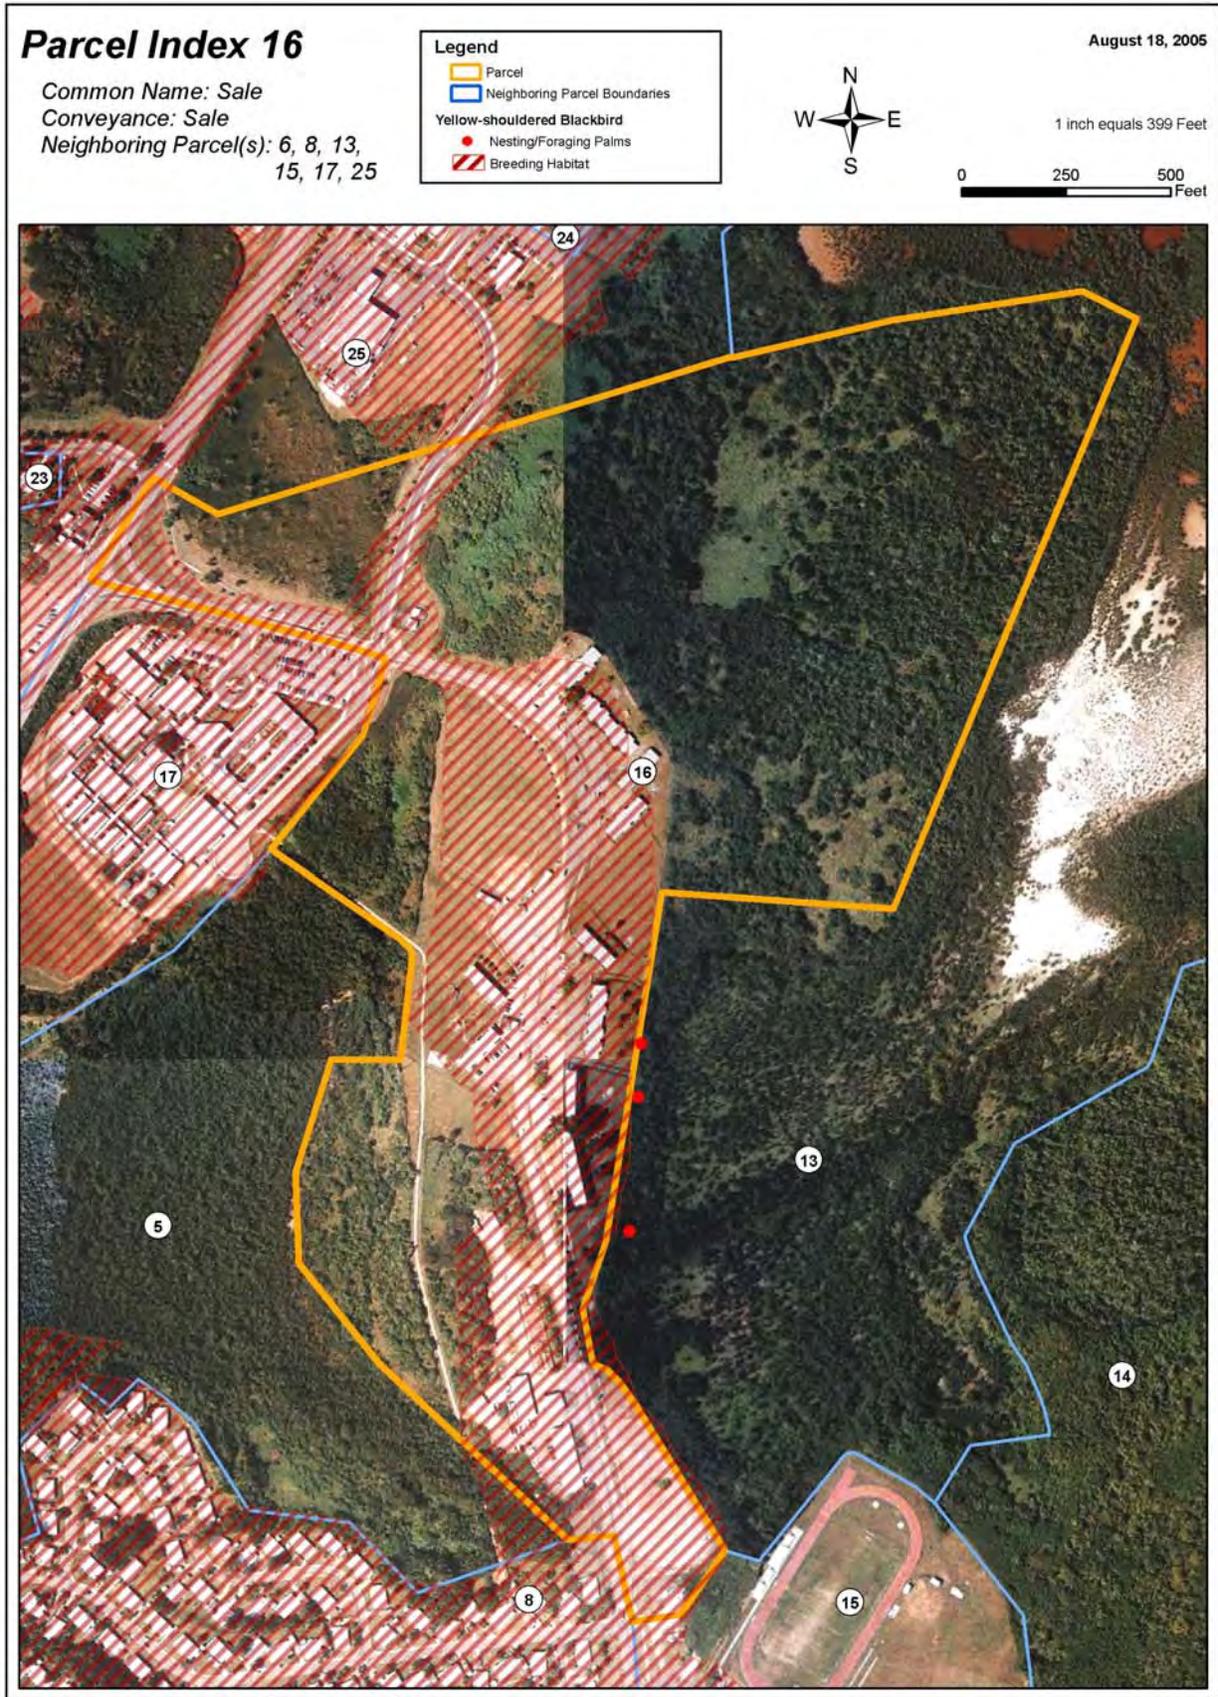
### Parcel Index 16

Common Name: Sale  
Conveyance: Sale  
Neighboring Parcel(s): 6, 8, 13,  
15, 17, 25

1 inch equals 399 Feet

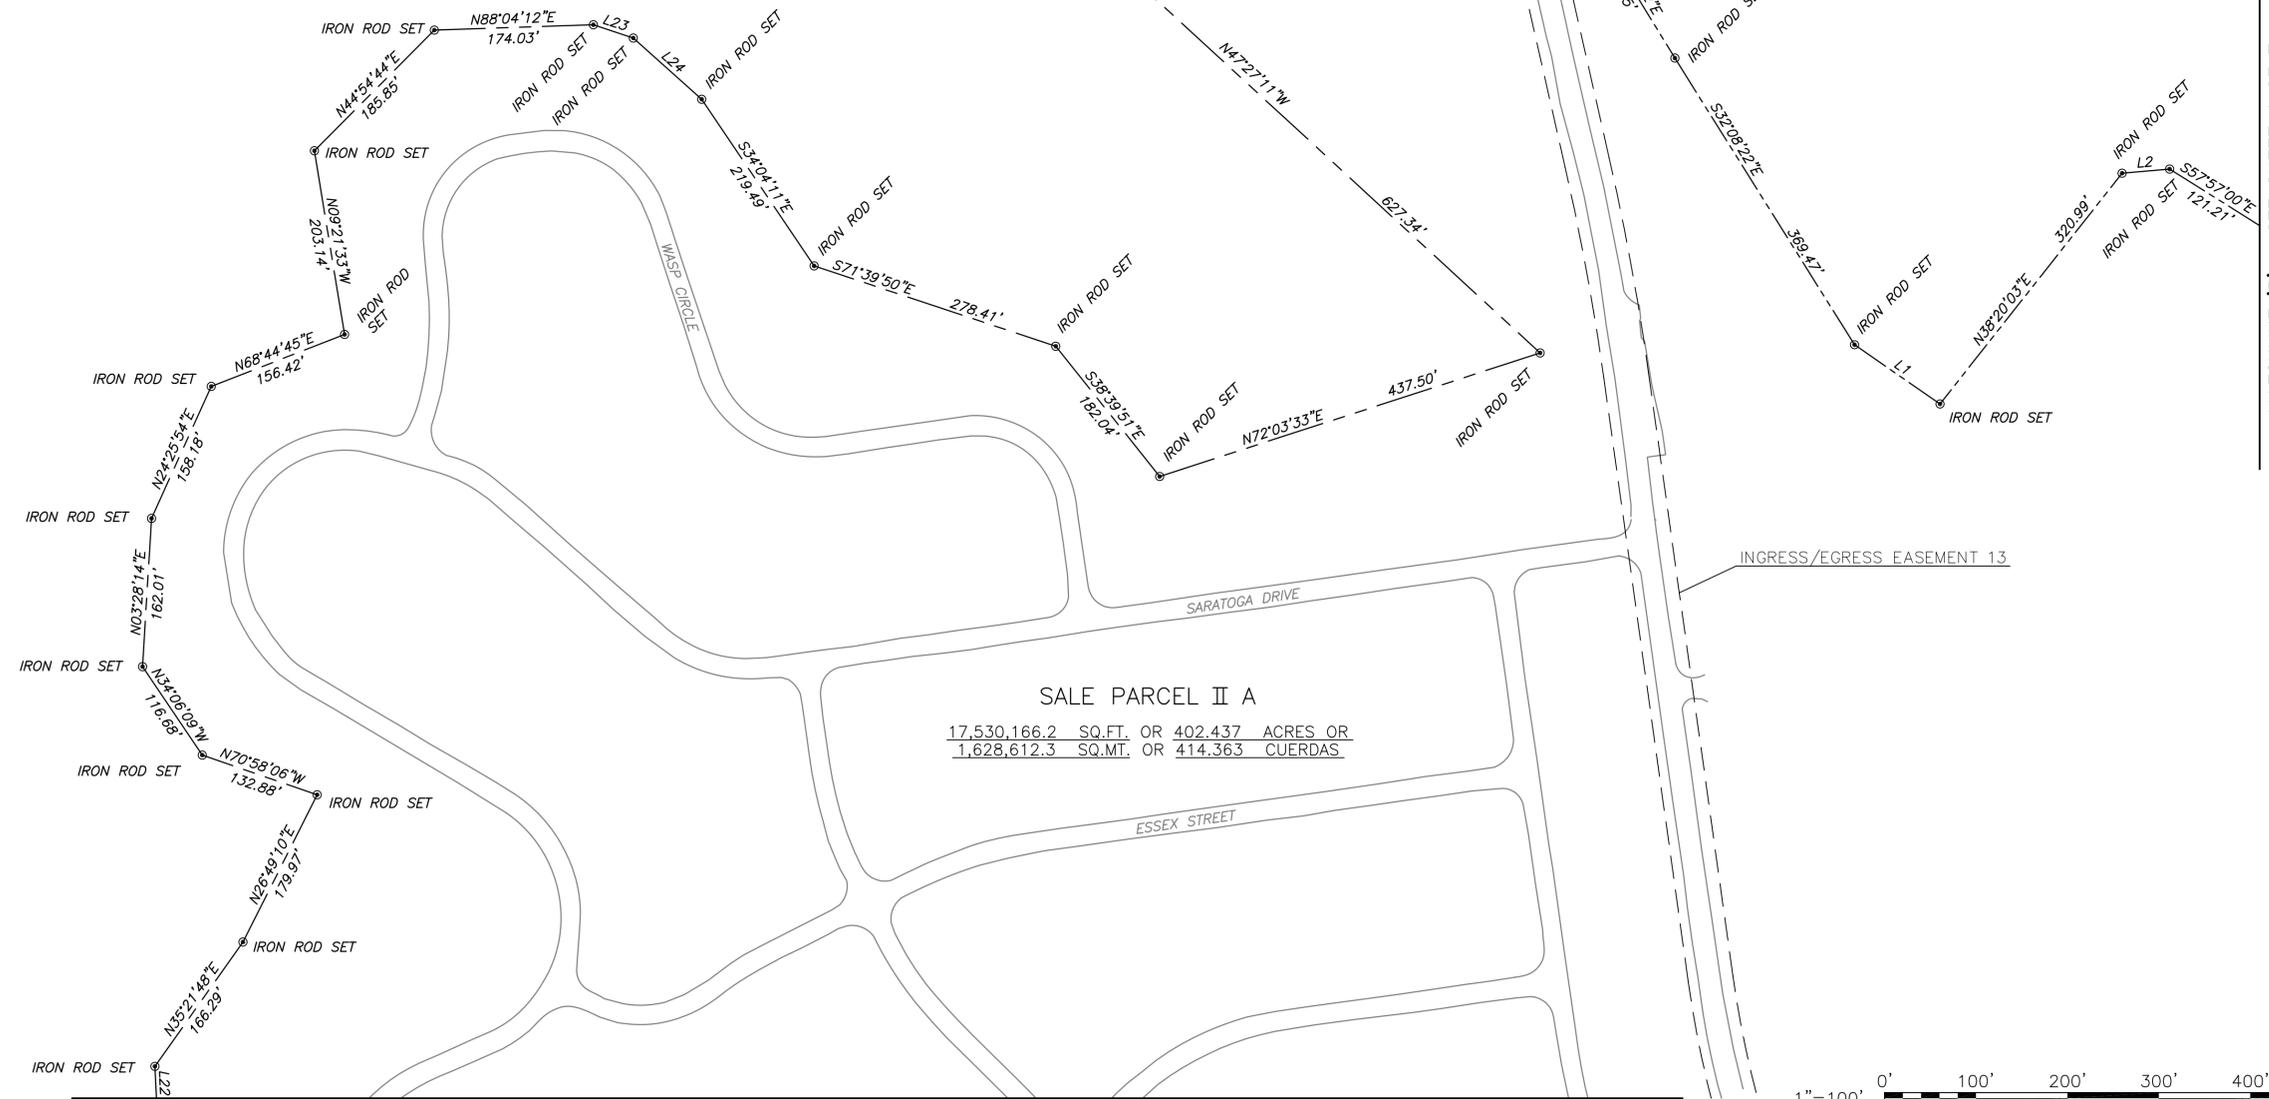
**Exhibit D**  
**Survey Map**

SALE PARCEL II A  
 17,530,166.2 SQ.FT. OR 402.437 ACRES OR  
 1,628,612.3 SQ.MT. OR 414.363 CUERDAS

INGRESS/EGRESS EASEMENT 13

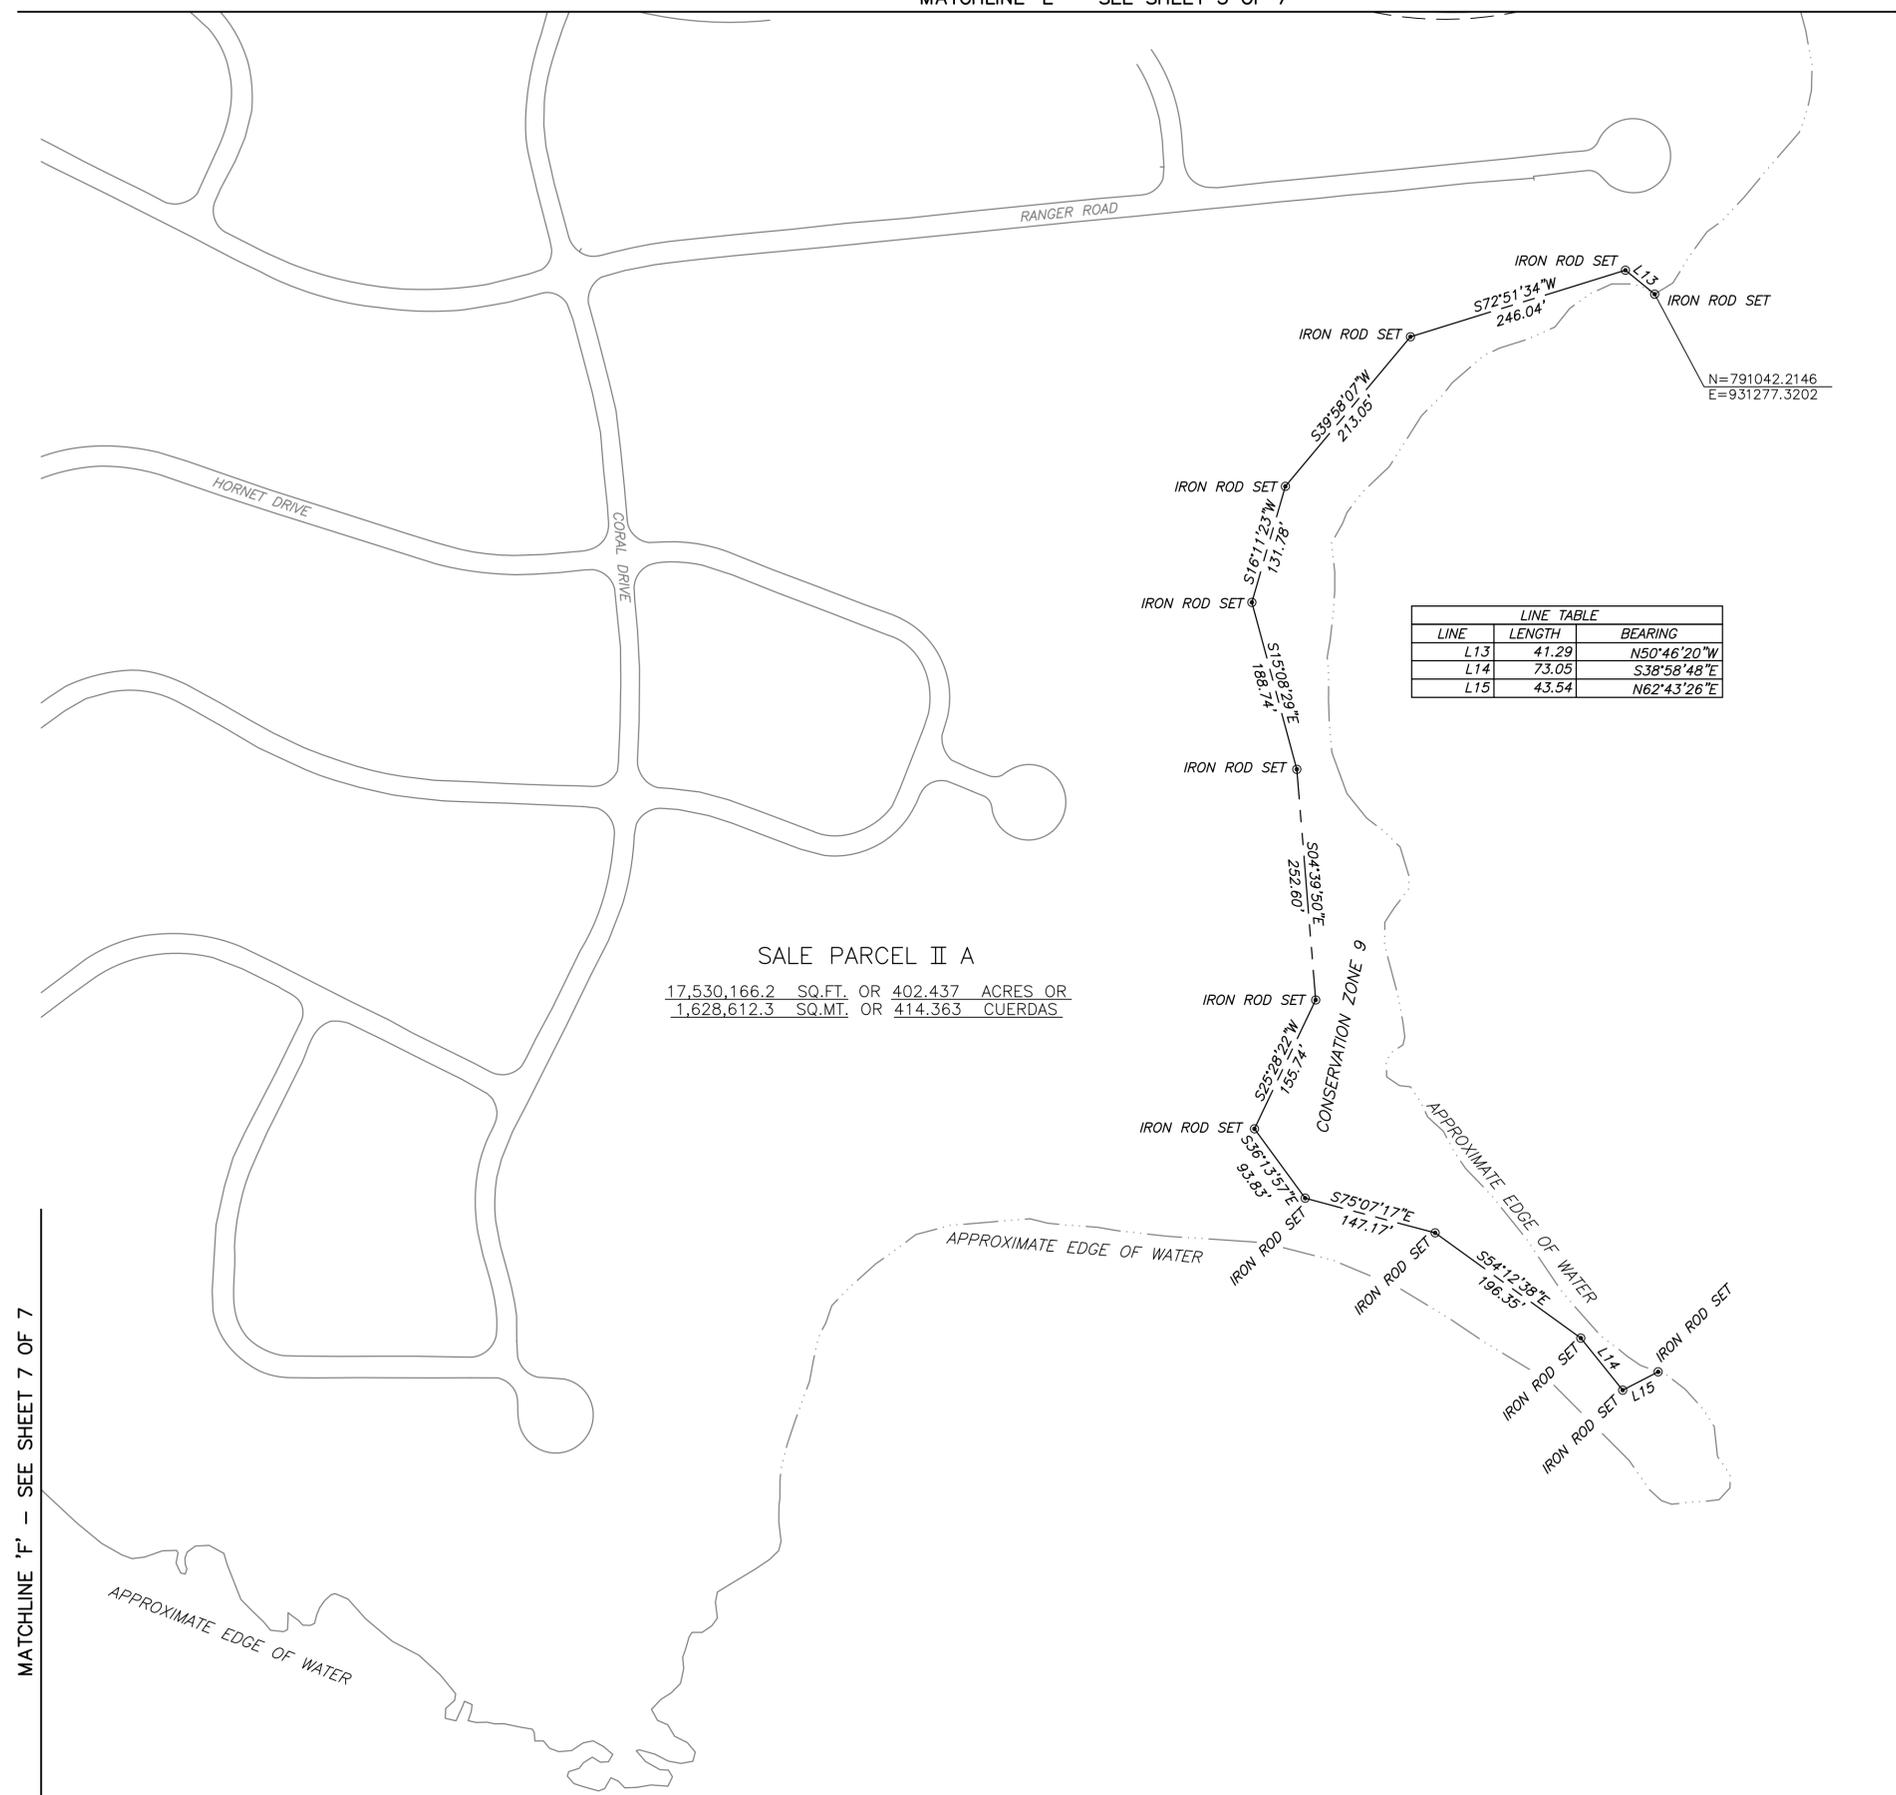
SALE PARCEL II A  
 17,530,166.2 SQ.FT. OR 402.437 ACRES OR  
 1,628,612.3 SQ.MT. OR 414.363 CUERDAS

LINE	LENGTH	BEARING
L13	41.29	N50°46'20"W
L14	73.05	S38°58'48"E
L15	43.54	N62°43'26"E

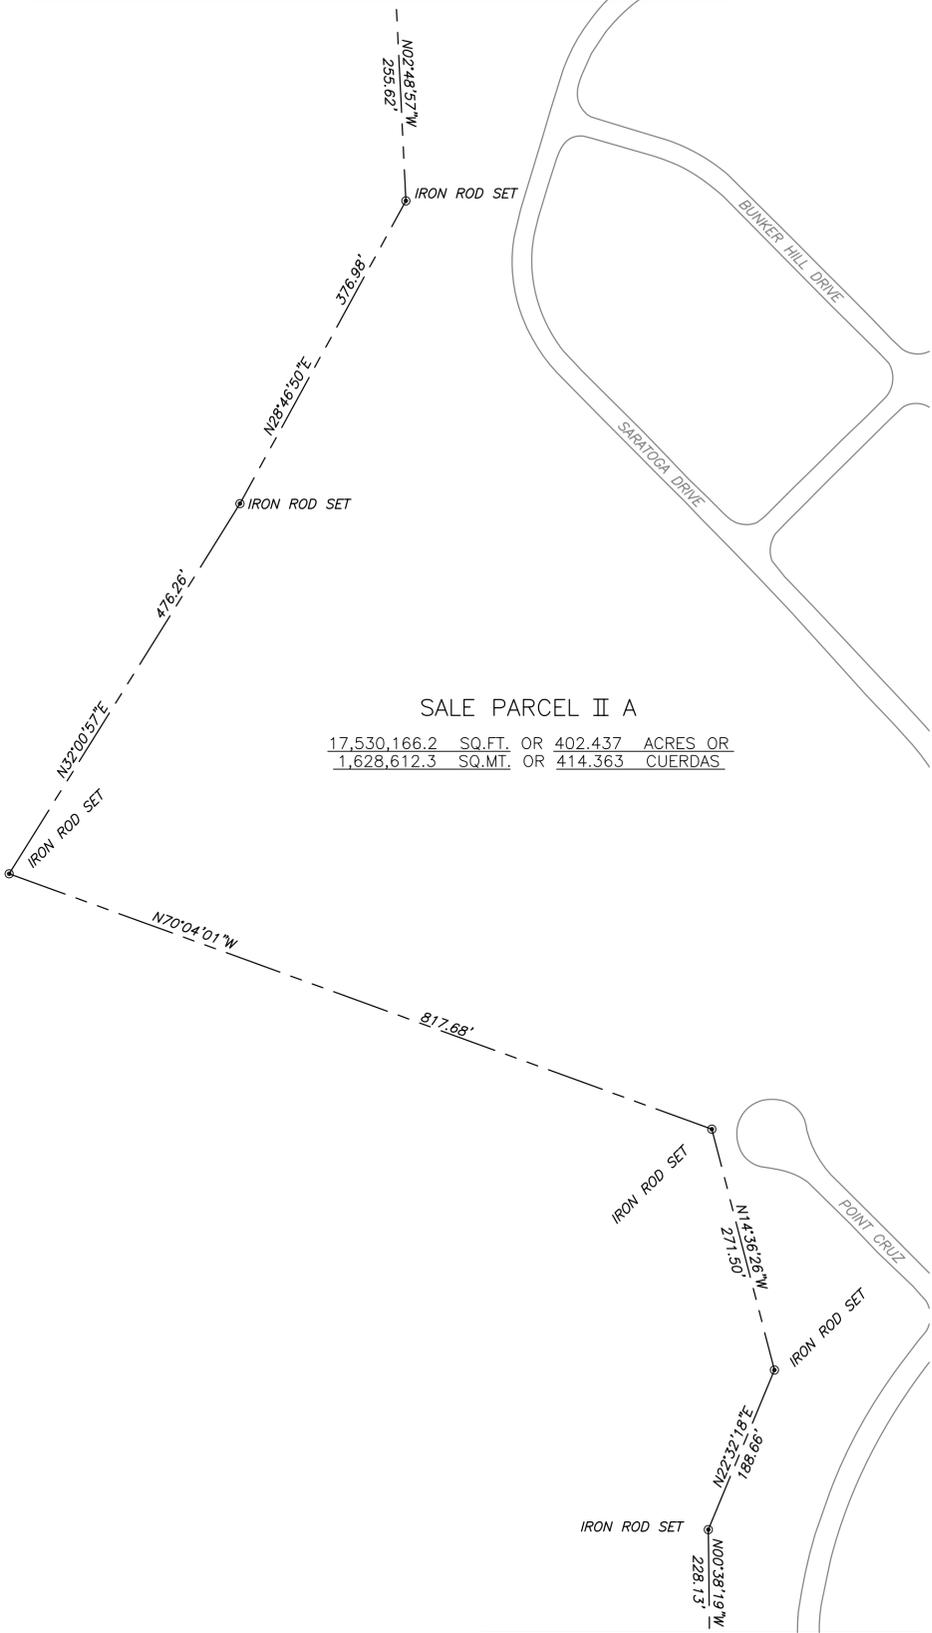
LINE	LENGTH	BEARING
L16	102.65	N02°18'32"E
L17	47.94	N52°52'48"W
L18	69.58	N20°16'57"W
L19	49.06	S64°17'45"W
L20	86.93	S30°25'00"W
L21	107.23	S86°09'24"W

SALE PARCEL II A  
 17,530,166.2 SQ.FT. OR 402.437 ACRES OR  
 1,628,612.3 SQ.MT. OR 414.363 CUERDAS

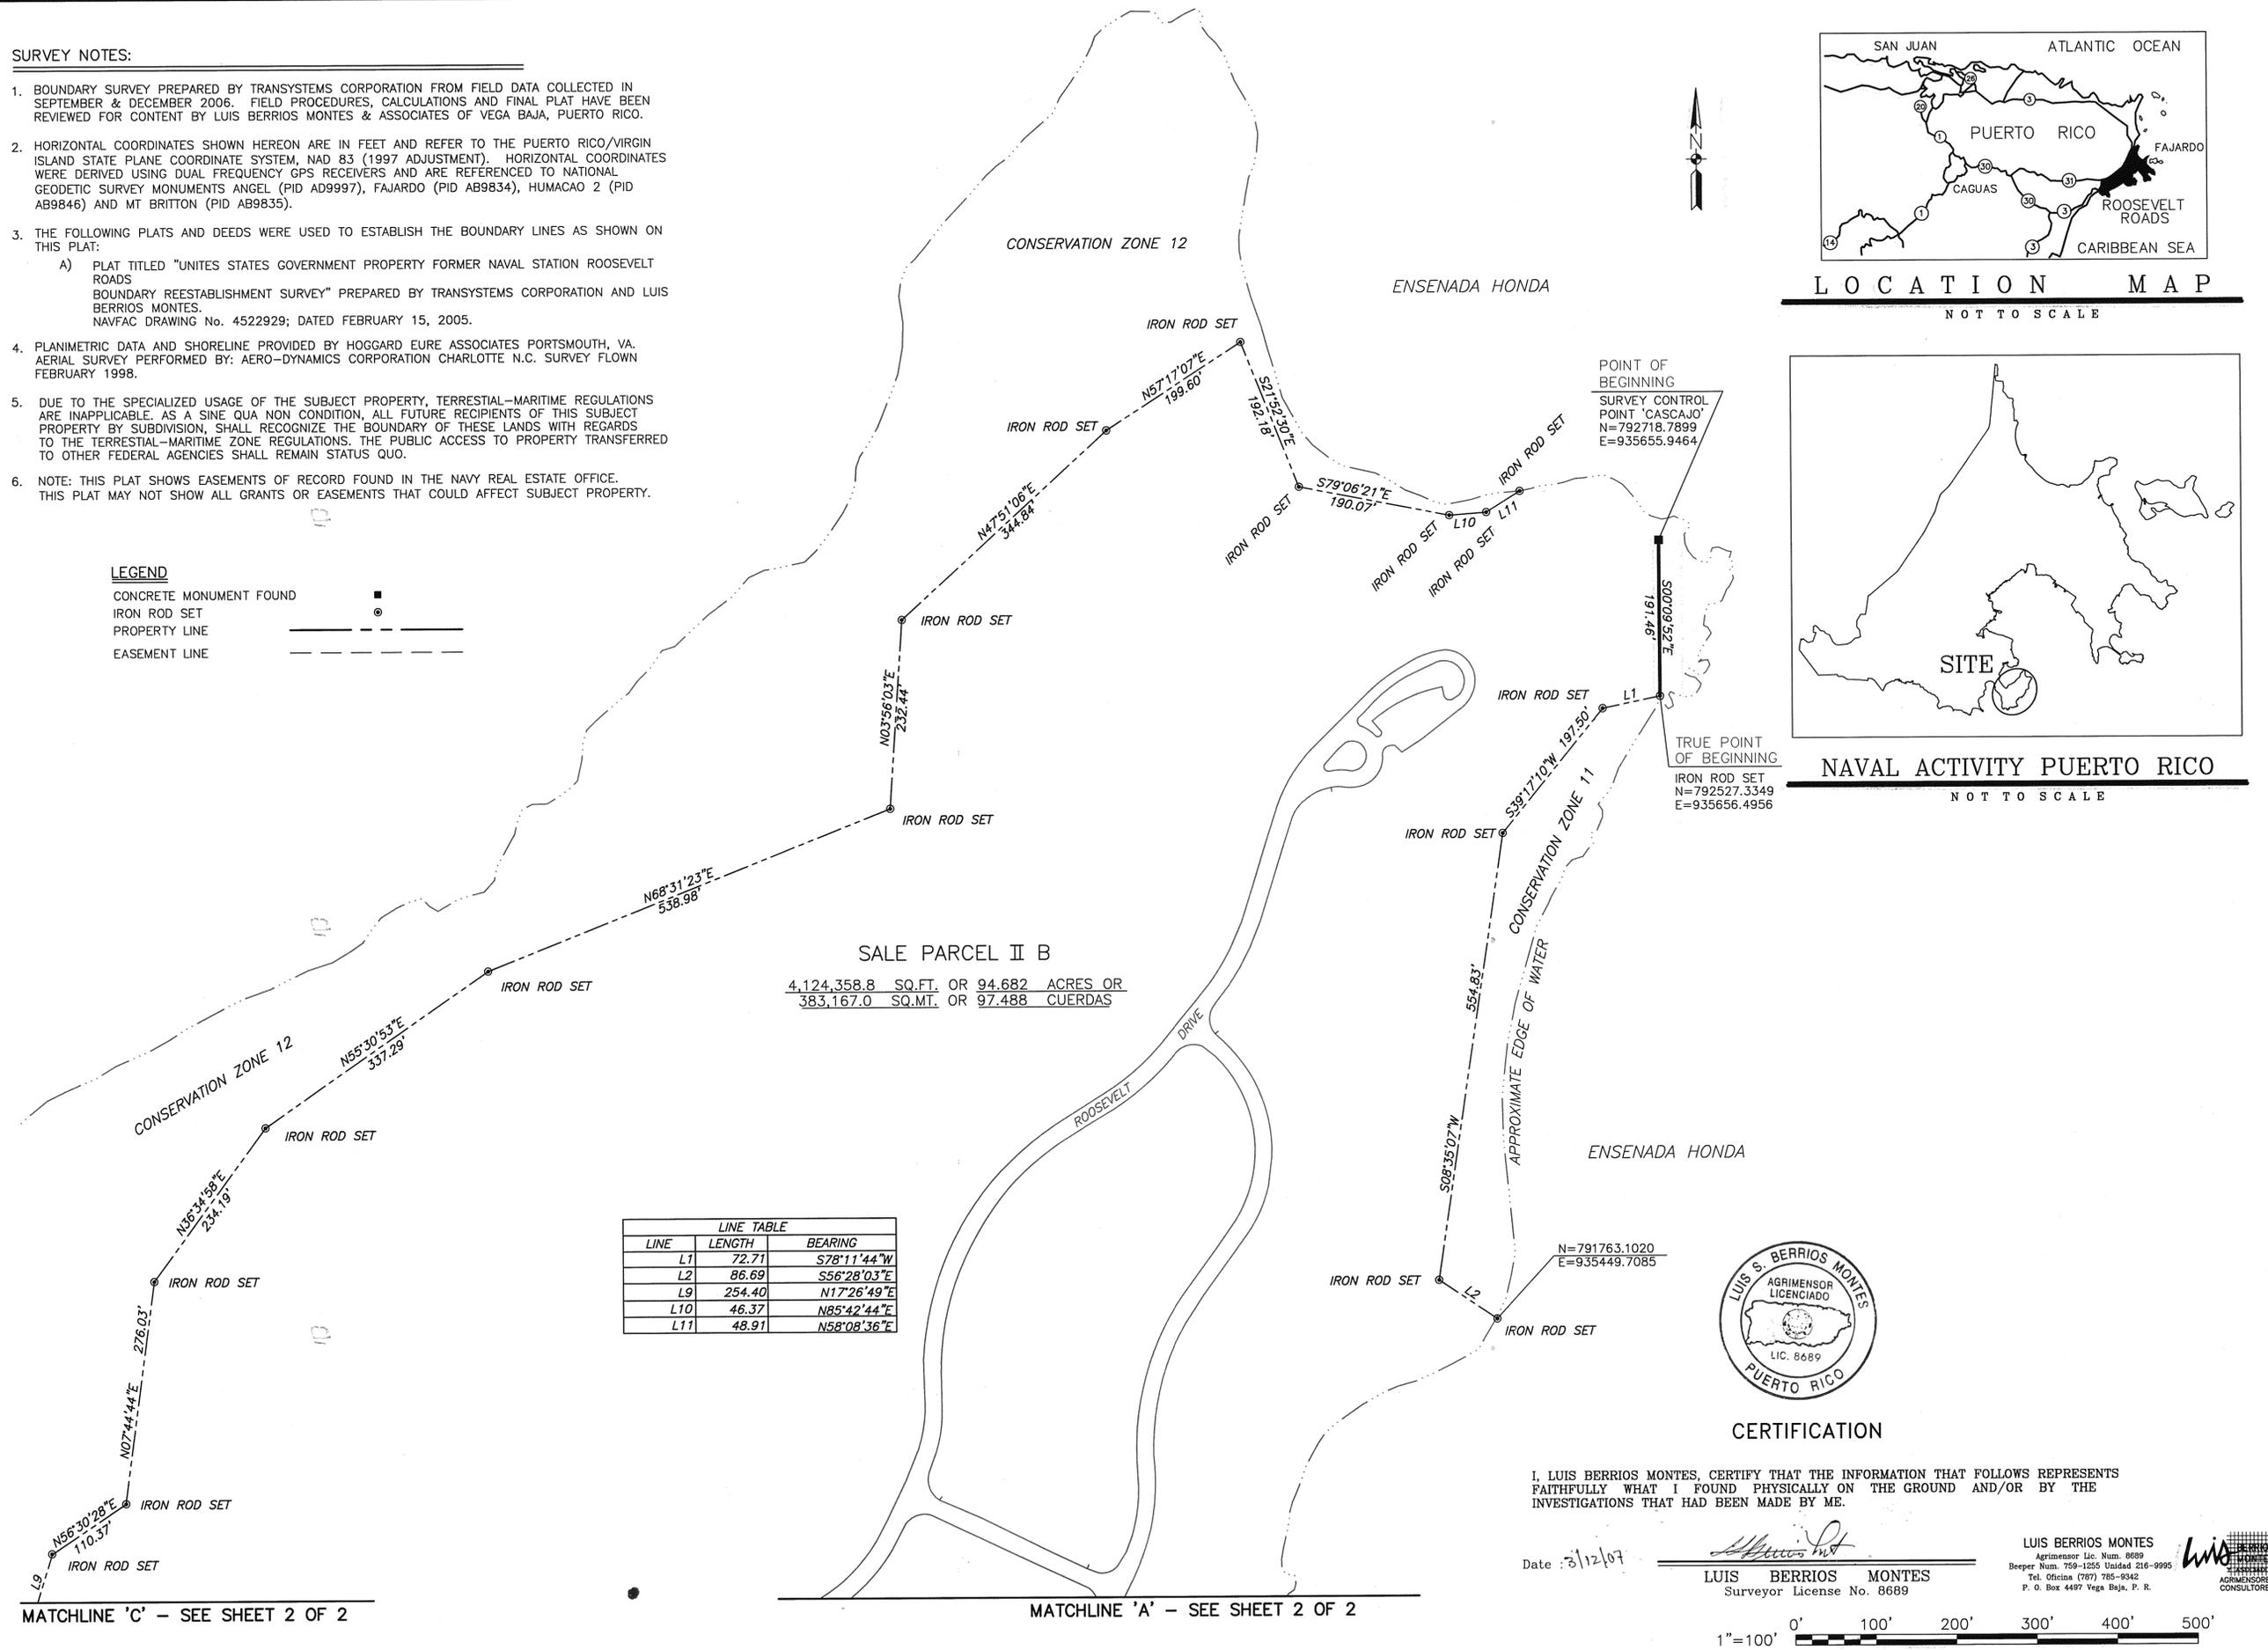
**SALE PARCEL II B**  
 4,124,358.8 SQ.FT. OR 94.682 ACRES OR  
 383,167.0 SQ.MT. OR 97.488 CUERDAS

LINE TABLE		
LINE	LENGTH	BEARING
L1	72.71	S78°11'44"W
L2	86.69	S56°28'03"E
L9	254.40	N17°26'49"E
L10	46.37	N85°42'44"E
L11	48.91	N58°08'36"E
